REPORT#: 22CA004

REPORT DATE: November 1, 2023

Contract Agricultural Worker Dies After Being Engulfed by Tons of Nuts — California

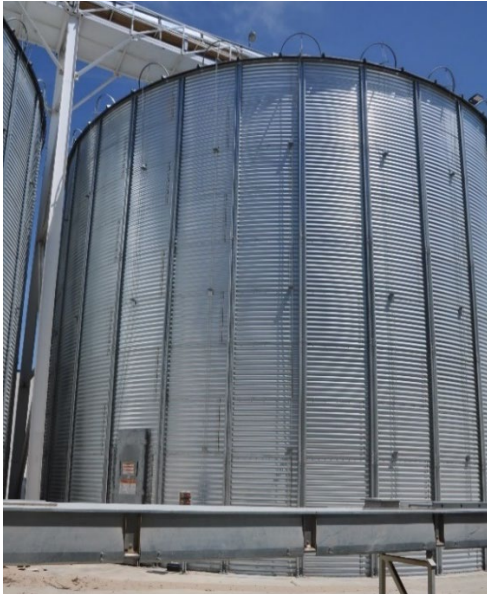
The primary piece of equipment involved in this incident was a GSI[®] Brand storage bin (silo) that had a maximum capacity of 850 tons (Exhibits 1 through 4). The nuts, once delivered to the processing facility, were moved by a series of conveyor belts and screw conveyors (augers) through various pieces of equipment to clean, hull, dry, size and sort the nuts prior to storing them in the silos. The nuts were stored in the silos prior to packaging and shipment to customers. The fill capacity of the silos was monitored by computer controllers for the process equipment as well as view ports located on the sides of the silos.

Exhibit 1. 850-ton storage silo.
Photos 1-3 by CA/FACE program.

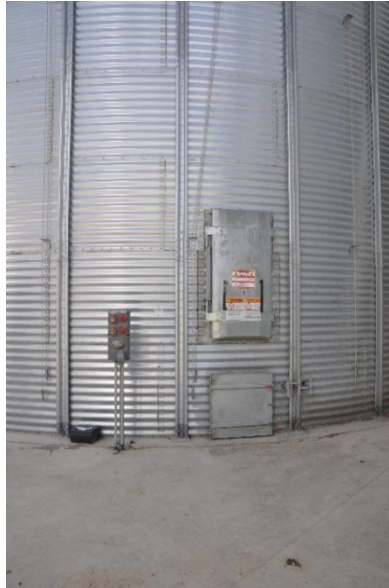
Exhibit 2 –Silo access door.

- *The host employer's silo involved in this incident did not have an inward swinging inner door installed as a safety feature.*

Recommendation #4: Ensure that storage silos are fitted with inward swinging inner access doors.

Discussion: In this case, the victim had opened the outer access door to a silo that was filled near capacity. Inward swinging doors (Exhibit 5) are a safety feature that ensures if the silo is filled with product, the pressure on the doors from the weight of the product prevents the doors from opening. If the silo had been fitted with inward swinging access doors, this incident may have been prevented.

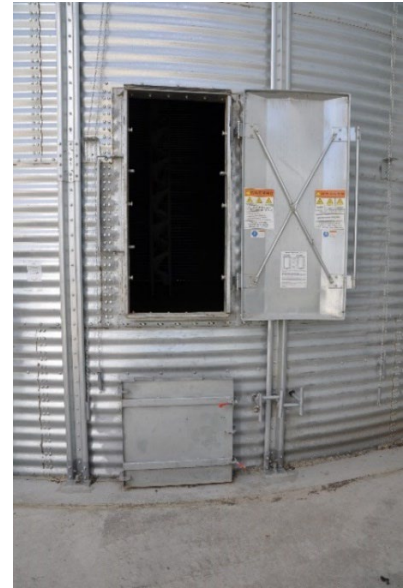
Exhibit 3 –Silo Access Door.

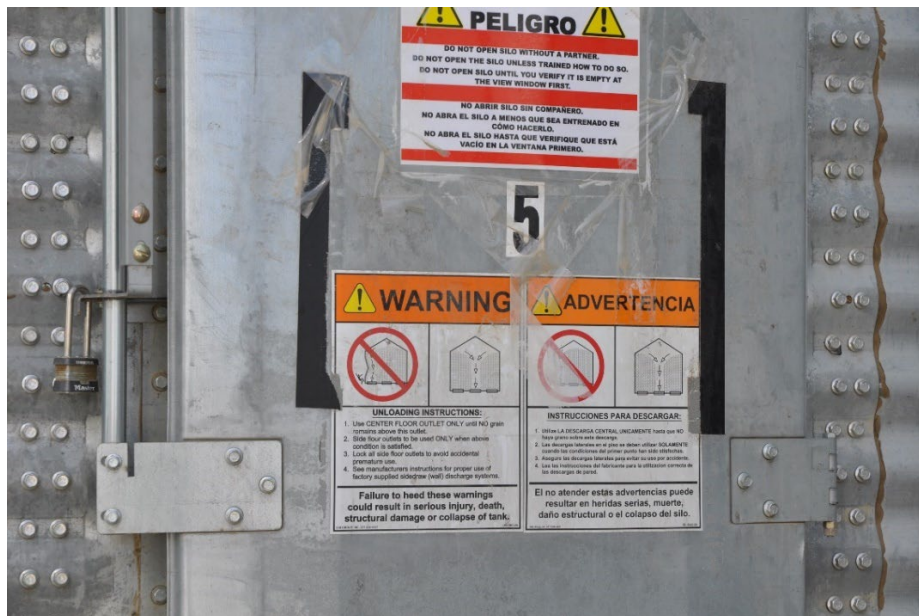
The incident scene was a well-lit outdoor storage area containing numerous silos and conveyor systems for transferring the nuts to and from the process equipment. Adjacent to the silo storage area was a process building where the nuts were segregated by size prior to being transferred into the silos, and a packaging line where the nuts were transferred from the silos into several different sized containers prior to shipment. There was no confined space warning sign on the silo doors prior to the incident.

Exhibit 4. Silo access door warning signs. Photo by CA/FACE program.

1. Posting warning signs on all silo entrance hatched to read “Danger! Potential atmospheric and engulfment hazards. Do not enter without management authorization” or similar language.
2. Keep all silo doors locked except when entering, and only provide keys to trained, authorized individuals.
3. Only allow workers trained in the silo procedure to enter. The training should detail circumstances where entry is permissible and when it is not.
4. Conduct atmospheric testing prior to entry. If the silos have built-in fans, test each silo at least once to ensure that the fans are providing adequate ventilation to maintain a safe atmosphere.
5. Entries, even for declassified confined spaces, should never be done alone. As with any hazardous operation, one of more additional workers should be on scene to provide aid should conditions change.

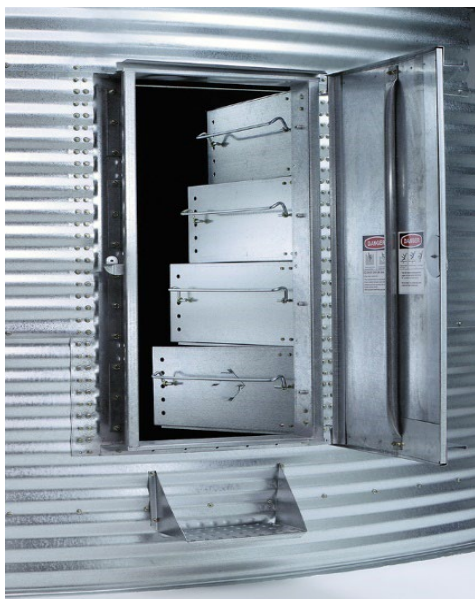
Exhibit 5. Inward swinging silo access doors.
Photo courtesy of Brock Grain Systems.
